Quebec Bridge Disaster

August 29, 1907

A 17 Month Commemorative Calendar

On August 29, 1907, the unfinished Quebec bridge collapsed.
Seventy-five lives were lost,
thirty-three of whom were Kahnawa'kehró:non.
This publication is in honor of those men and their families.

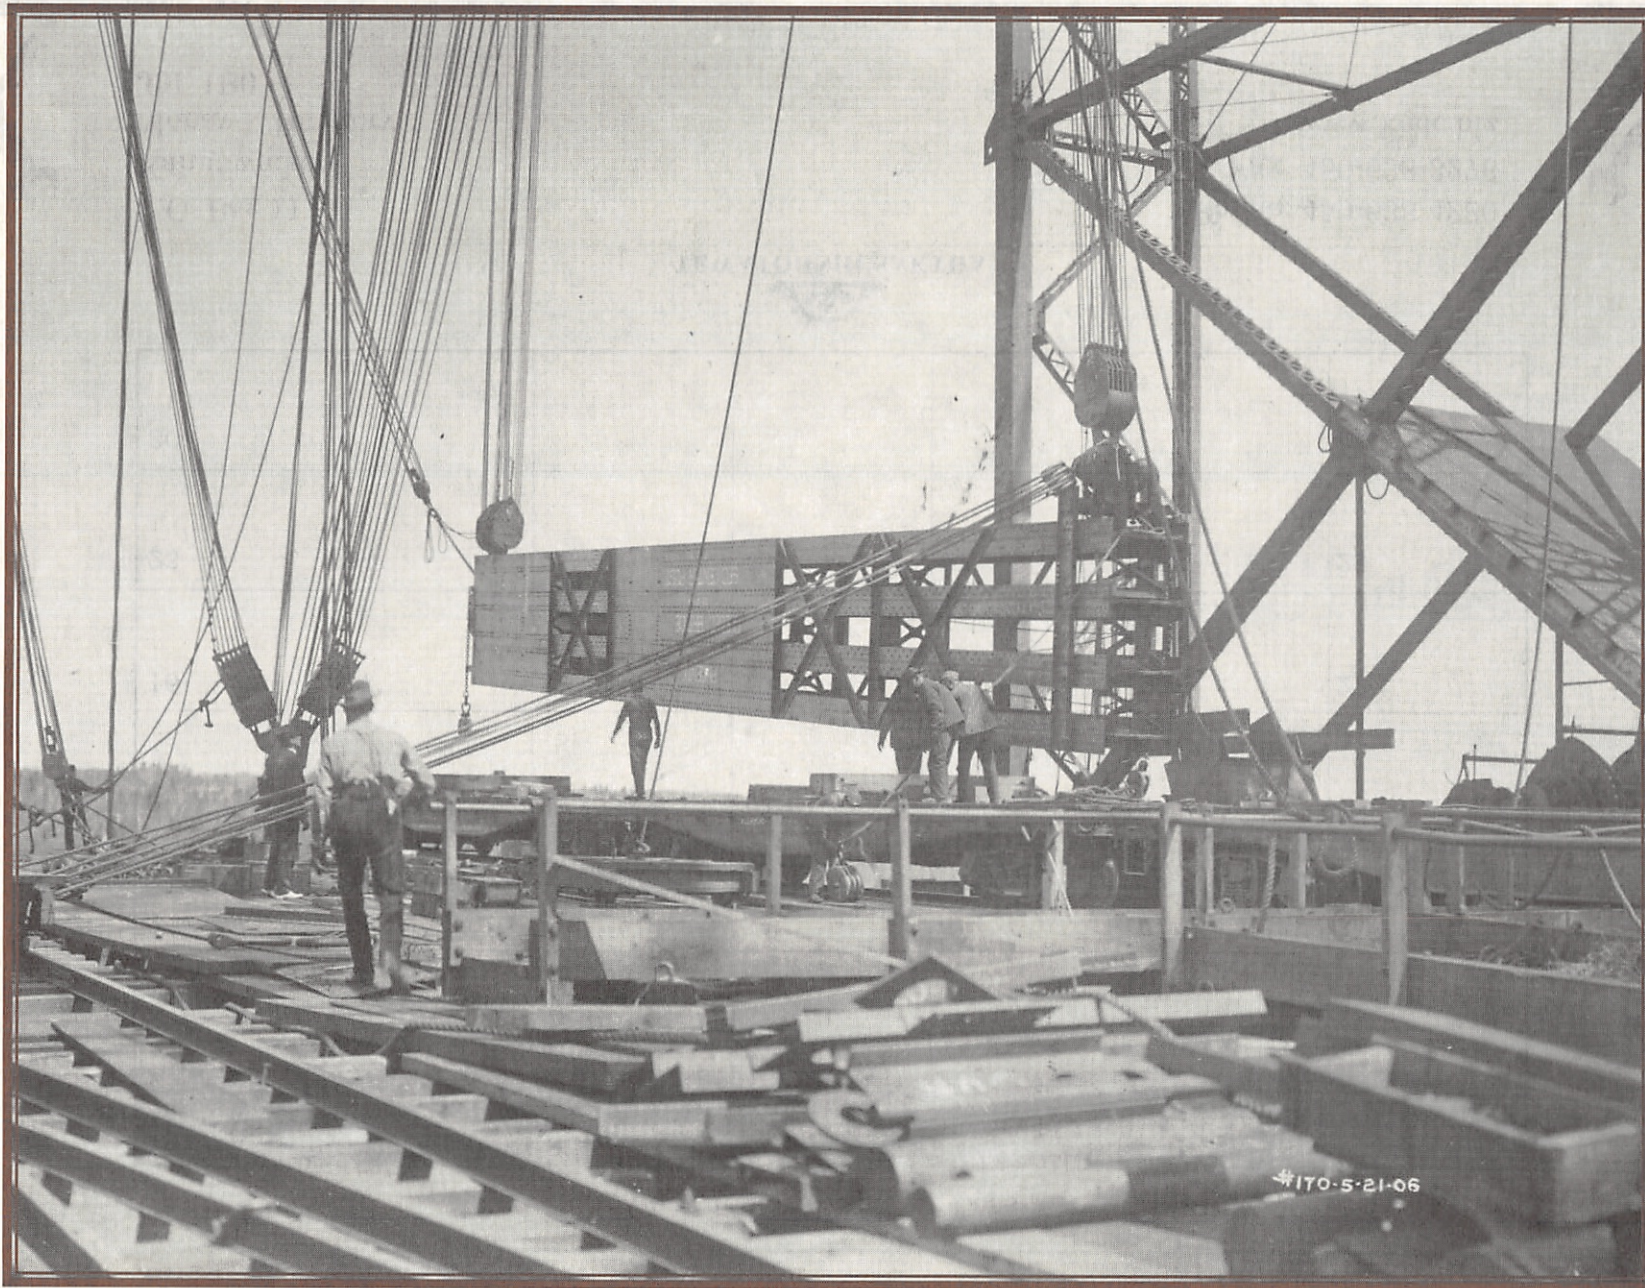
View of a center post section being lifted by the traveler.
(May 21, 1906)

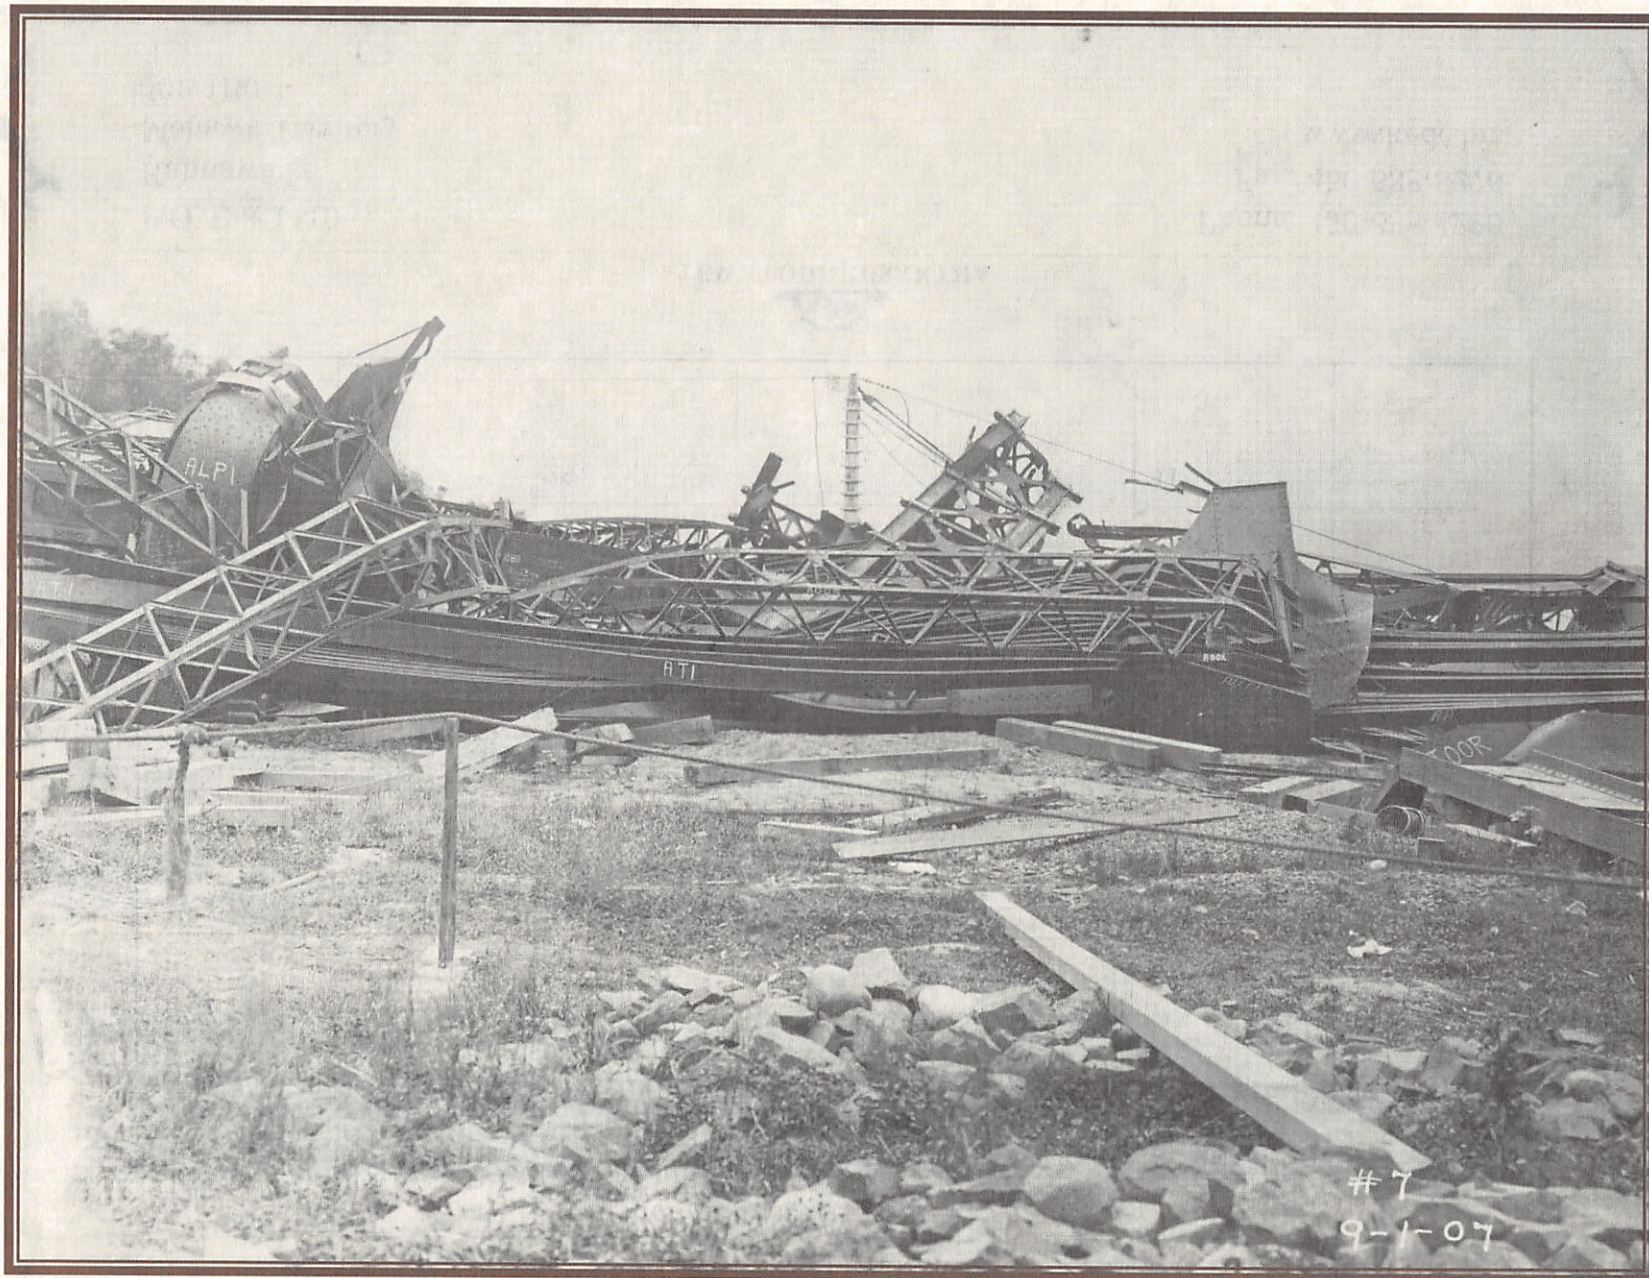
View near the top of post P.1.R. Note the line of the diagonal
eyebars at A.T.I. and the top chord of the eyebars A.A.

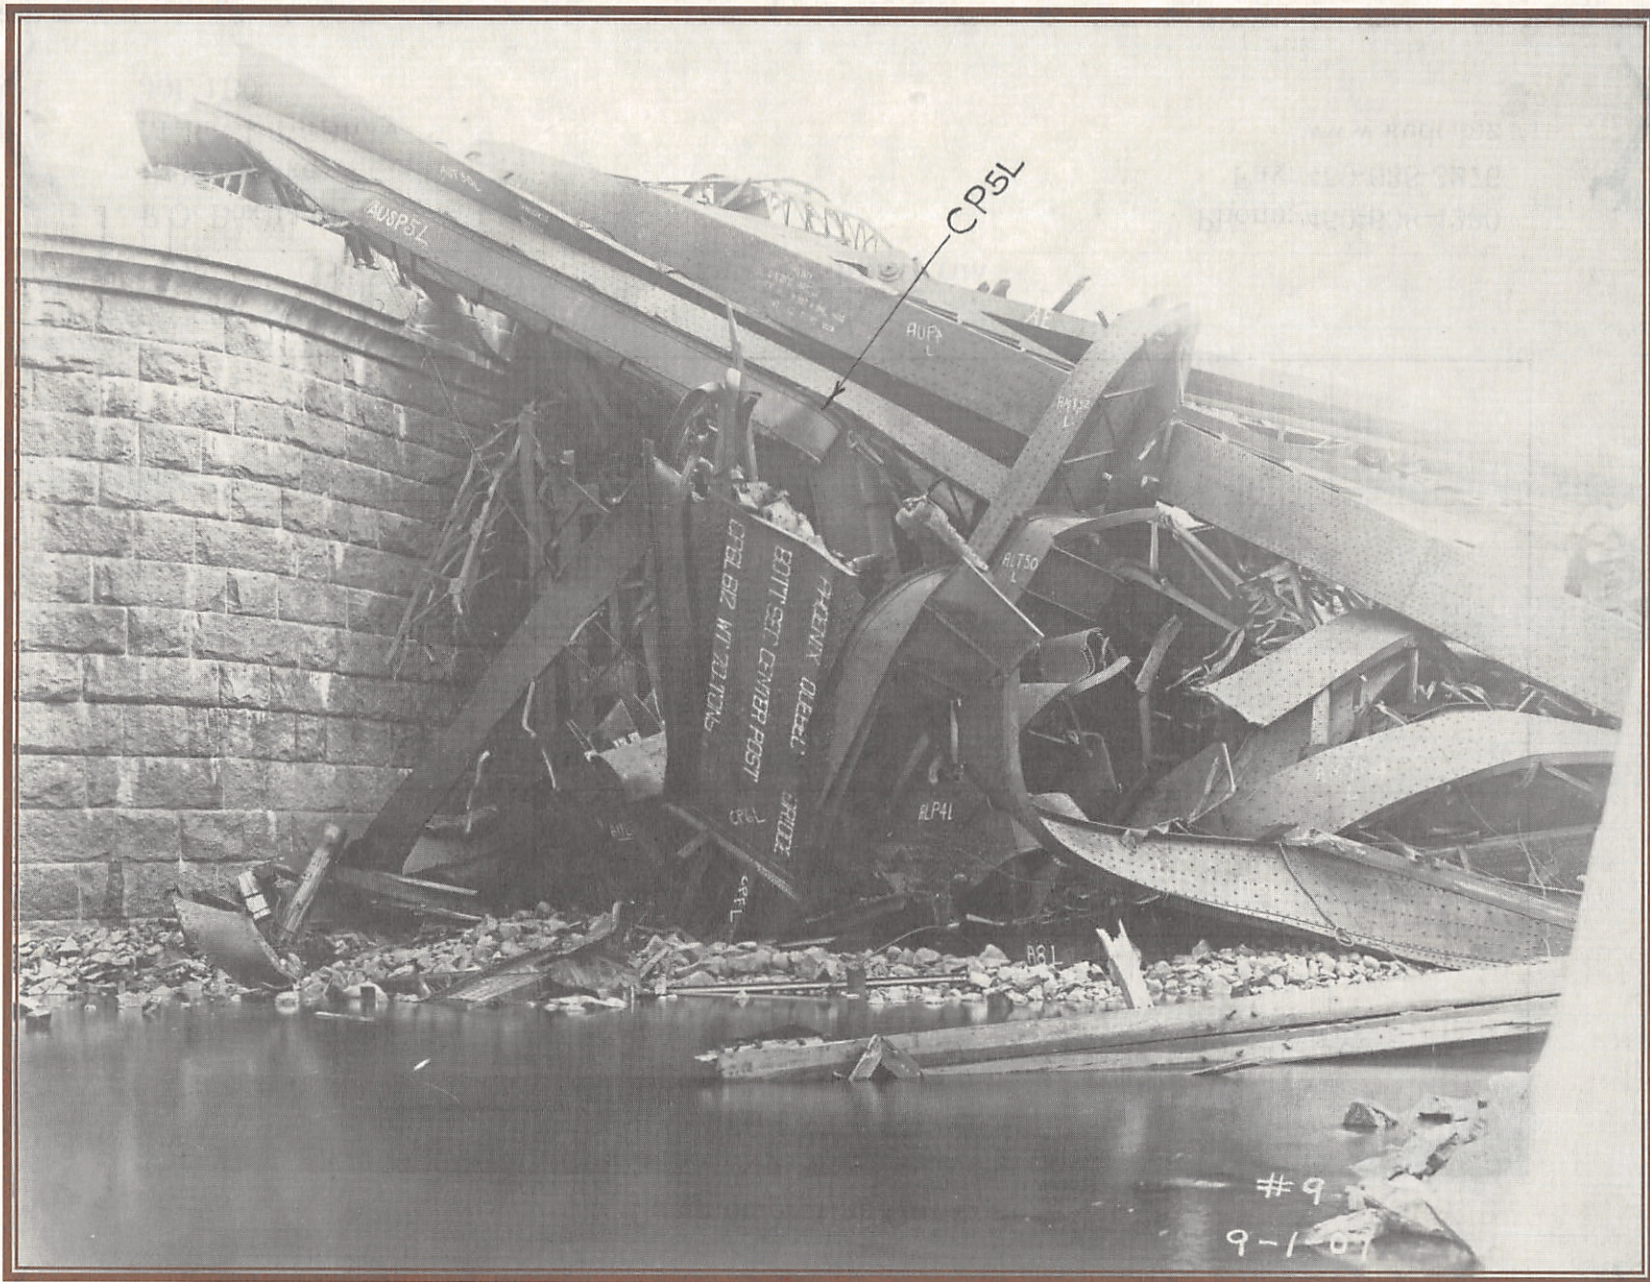
View from the west of the wreckage inside the main pier. Note the twisted web of A-8-L; the lower end post of P.4 inside C.P.6L; the splice plates between A-11-L and A-10-L cantilever arm; CP5L; and the spawling of the masonry coping which was struck by A-11-L

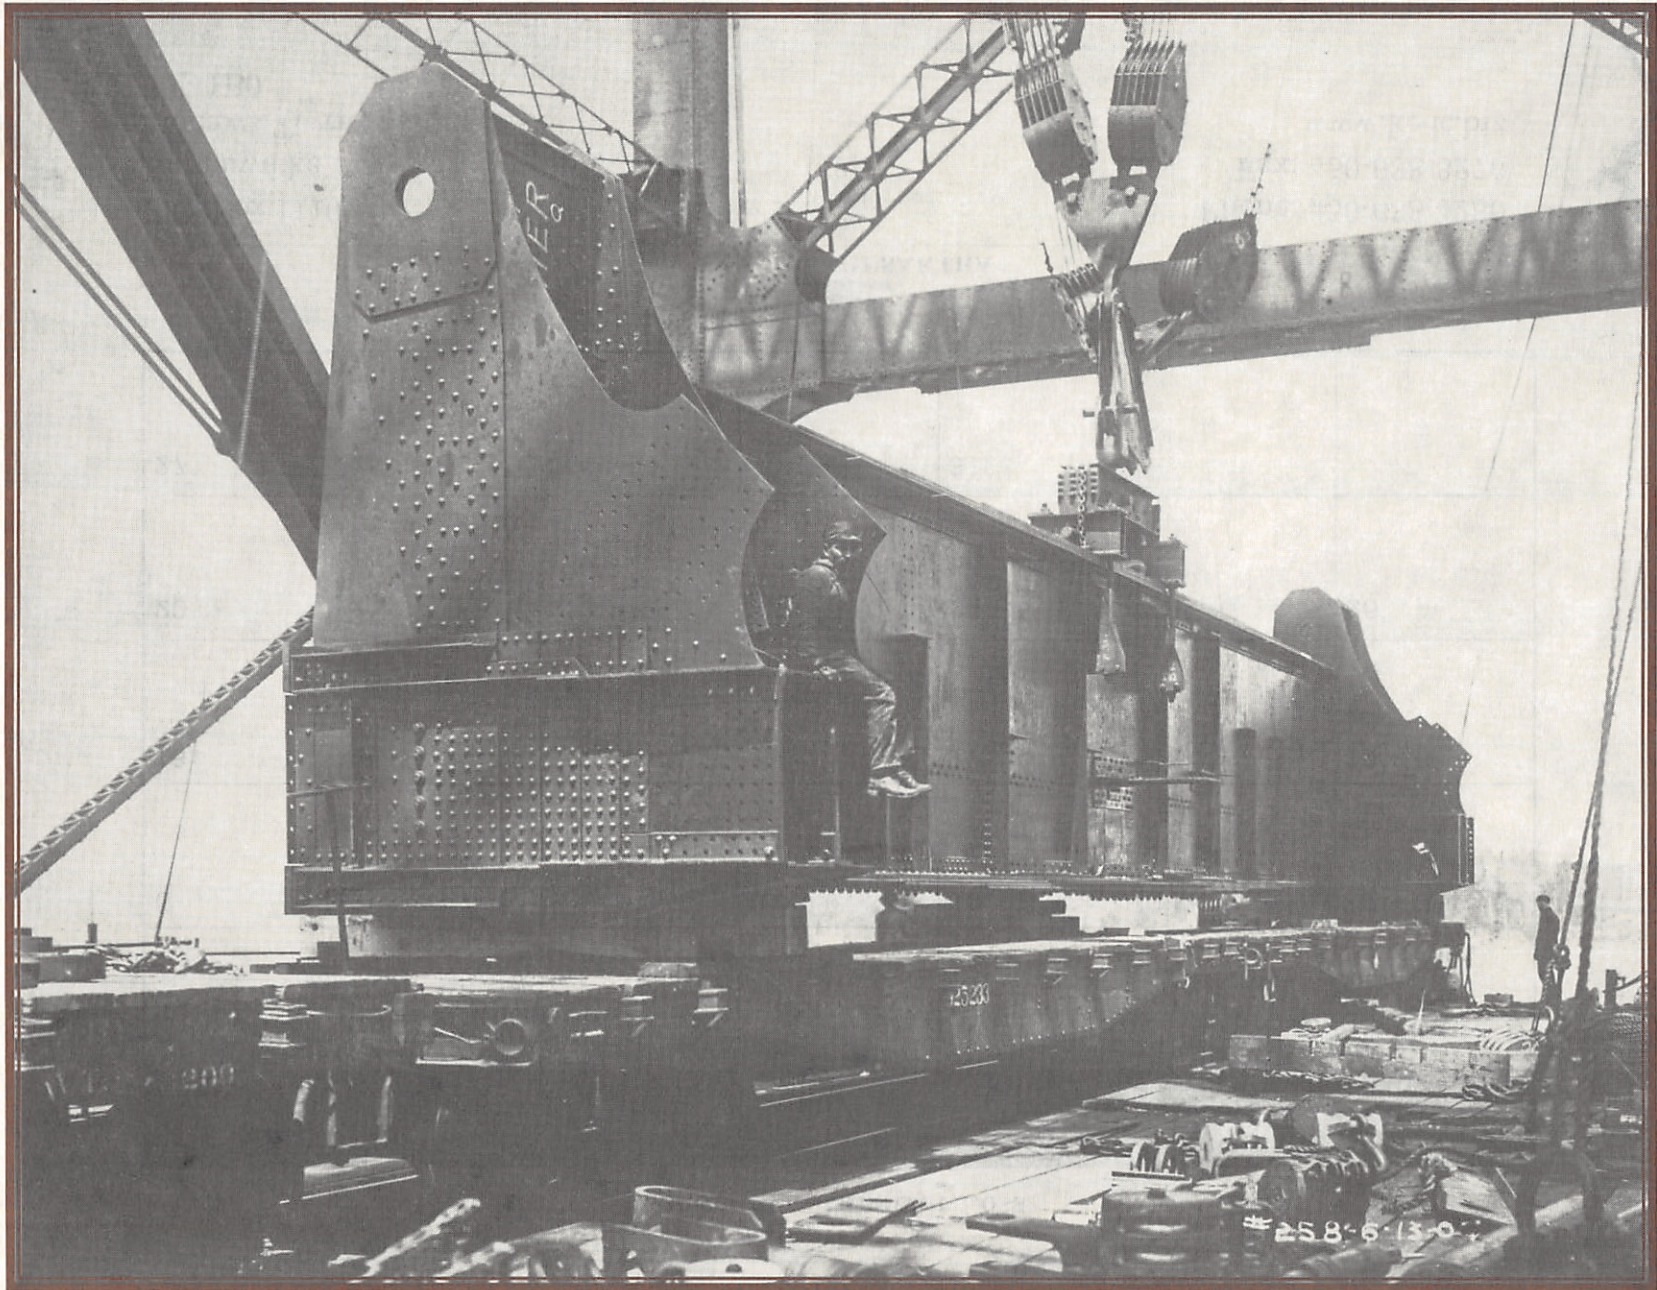
View showing the end floor beam of the suspended span.
(June 13, 1907)

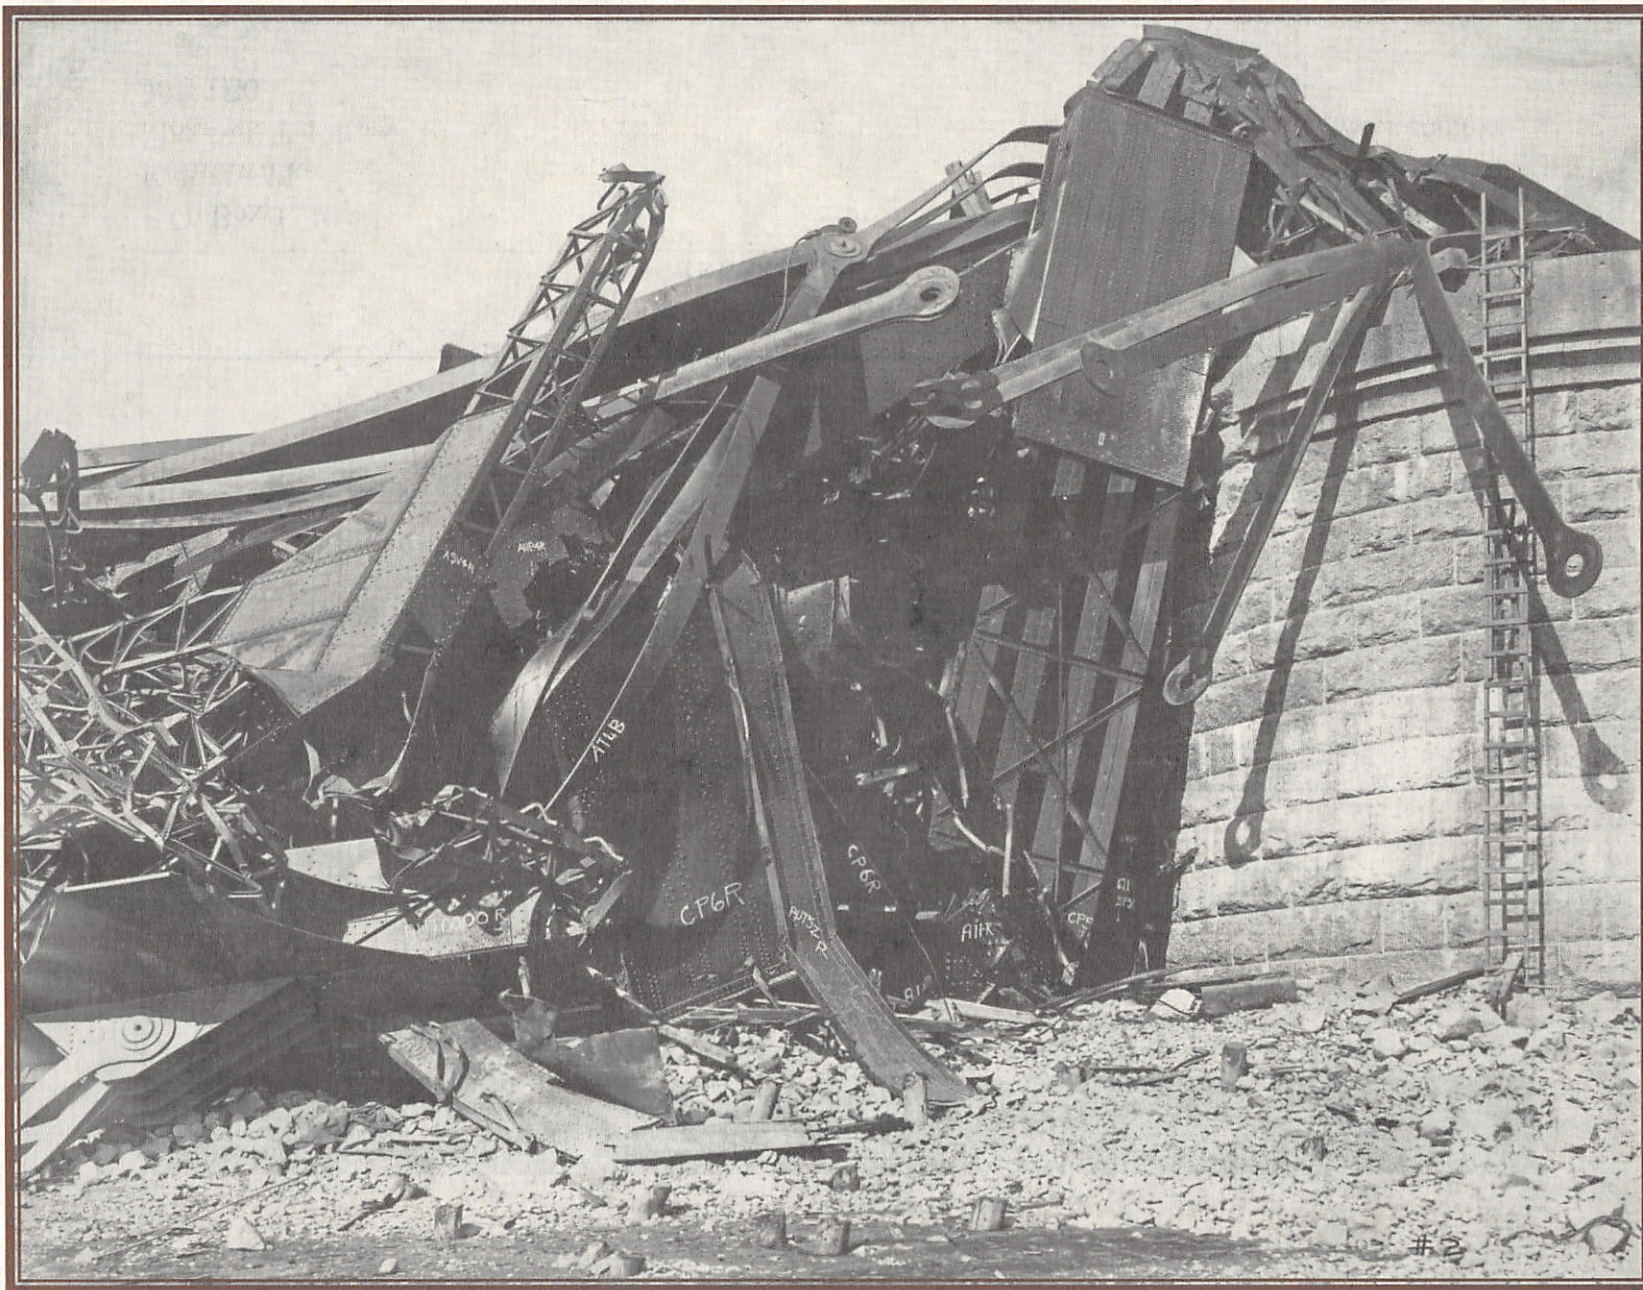
View from the east of wreckage inside main pier. Note the condition of C.P.6, which is standing in the hole dug by the shoe; the wreck of C.P.4 across the top of the pier, and the trusting of P.4 inside C.P..

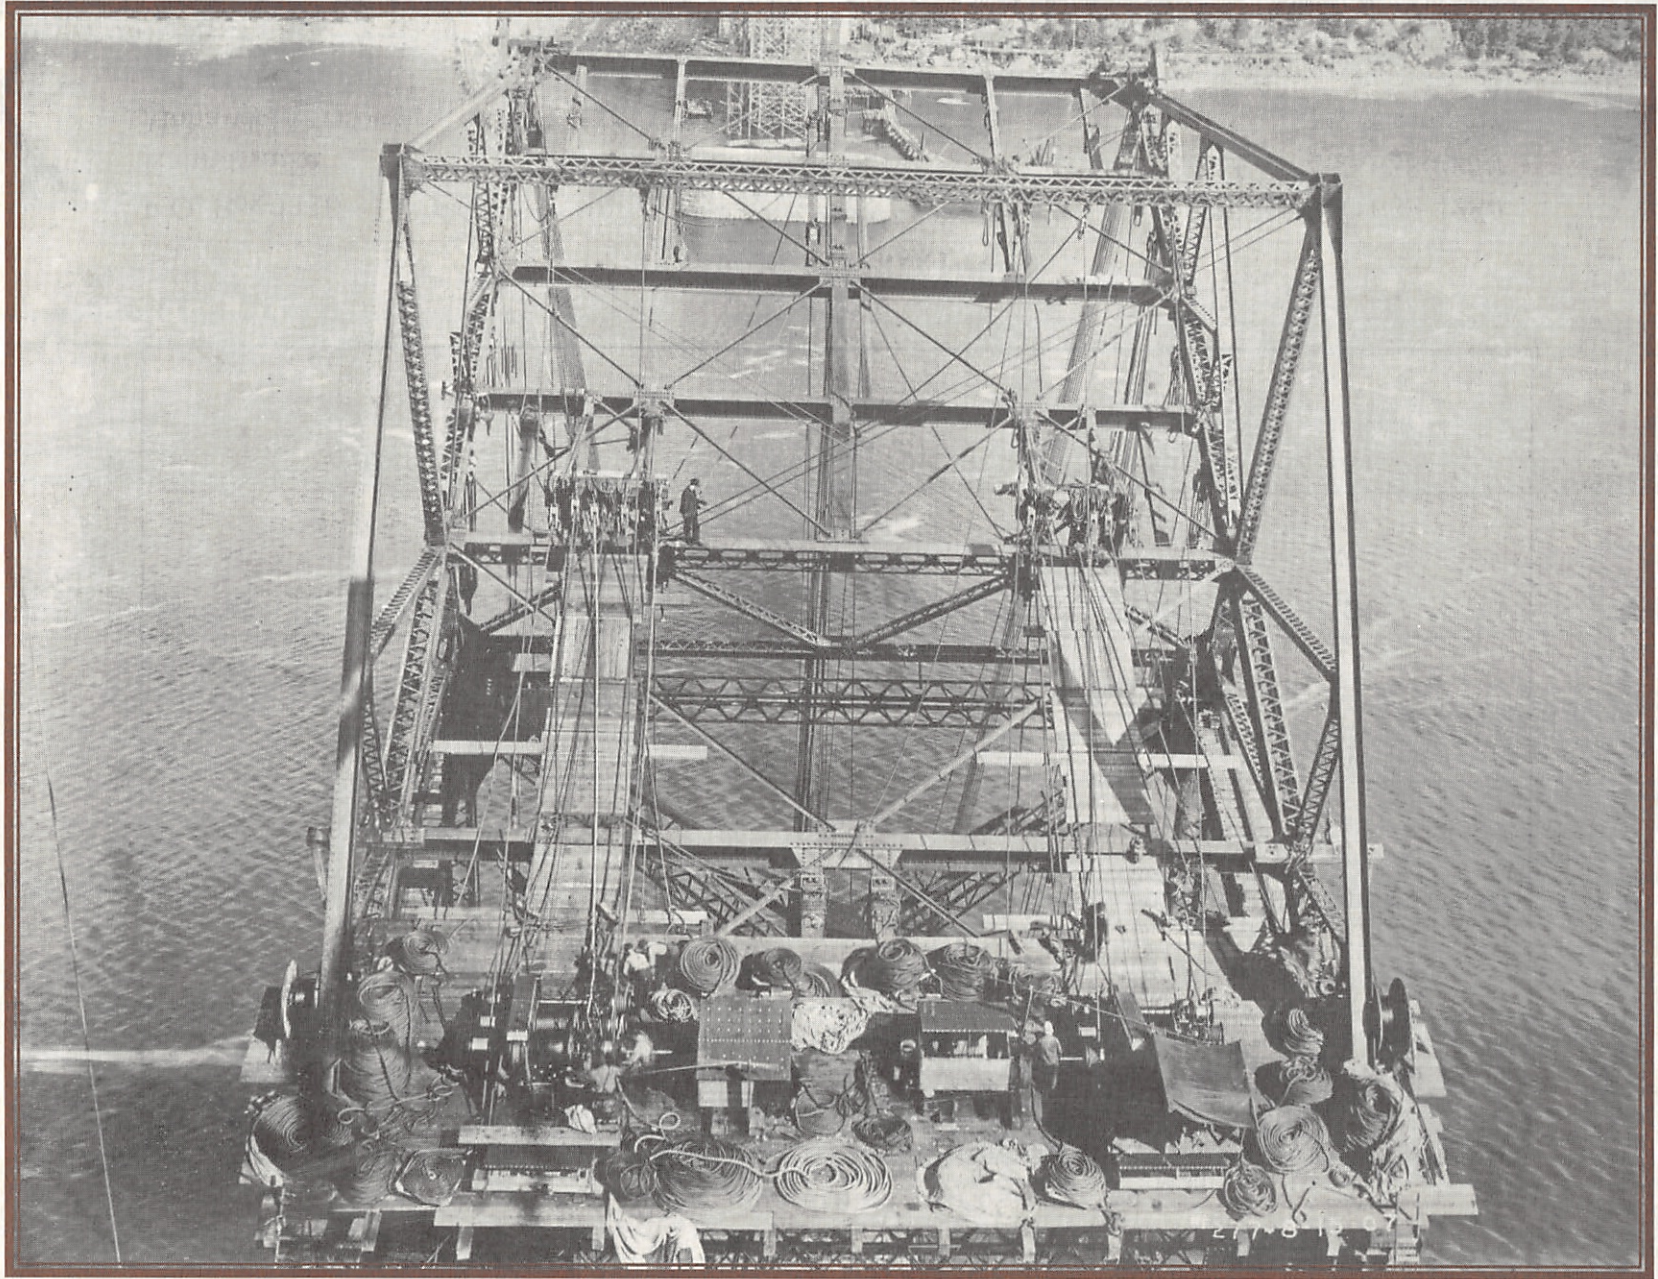
View showing the little traveler whilst erecting.
(August 15, 1907)

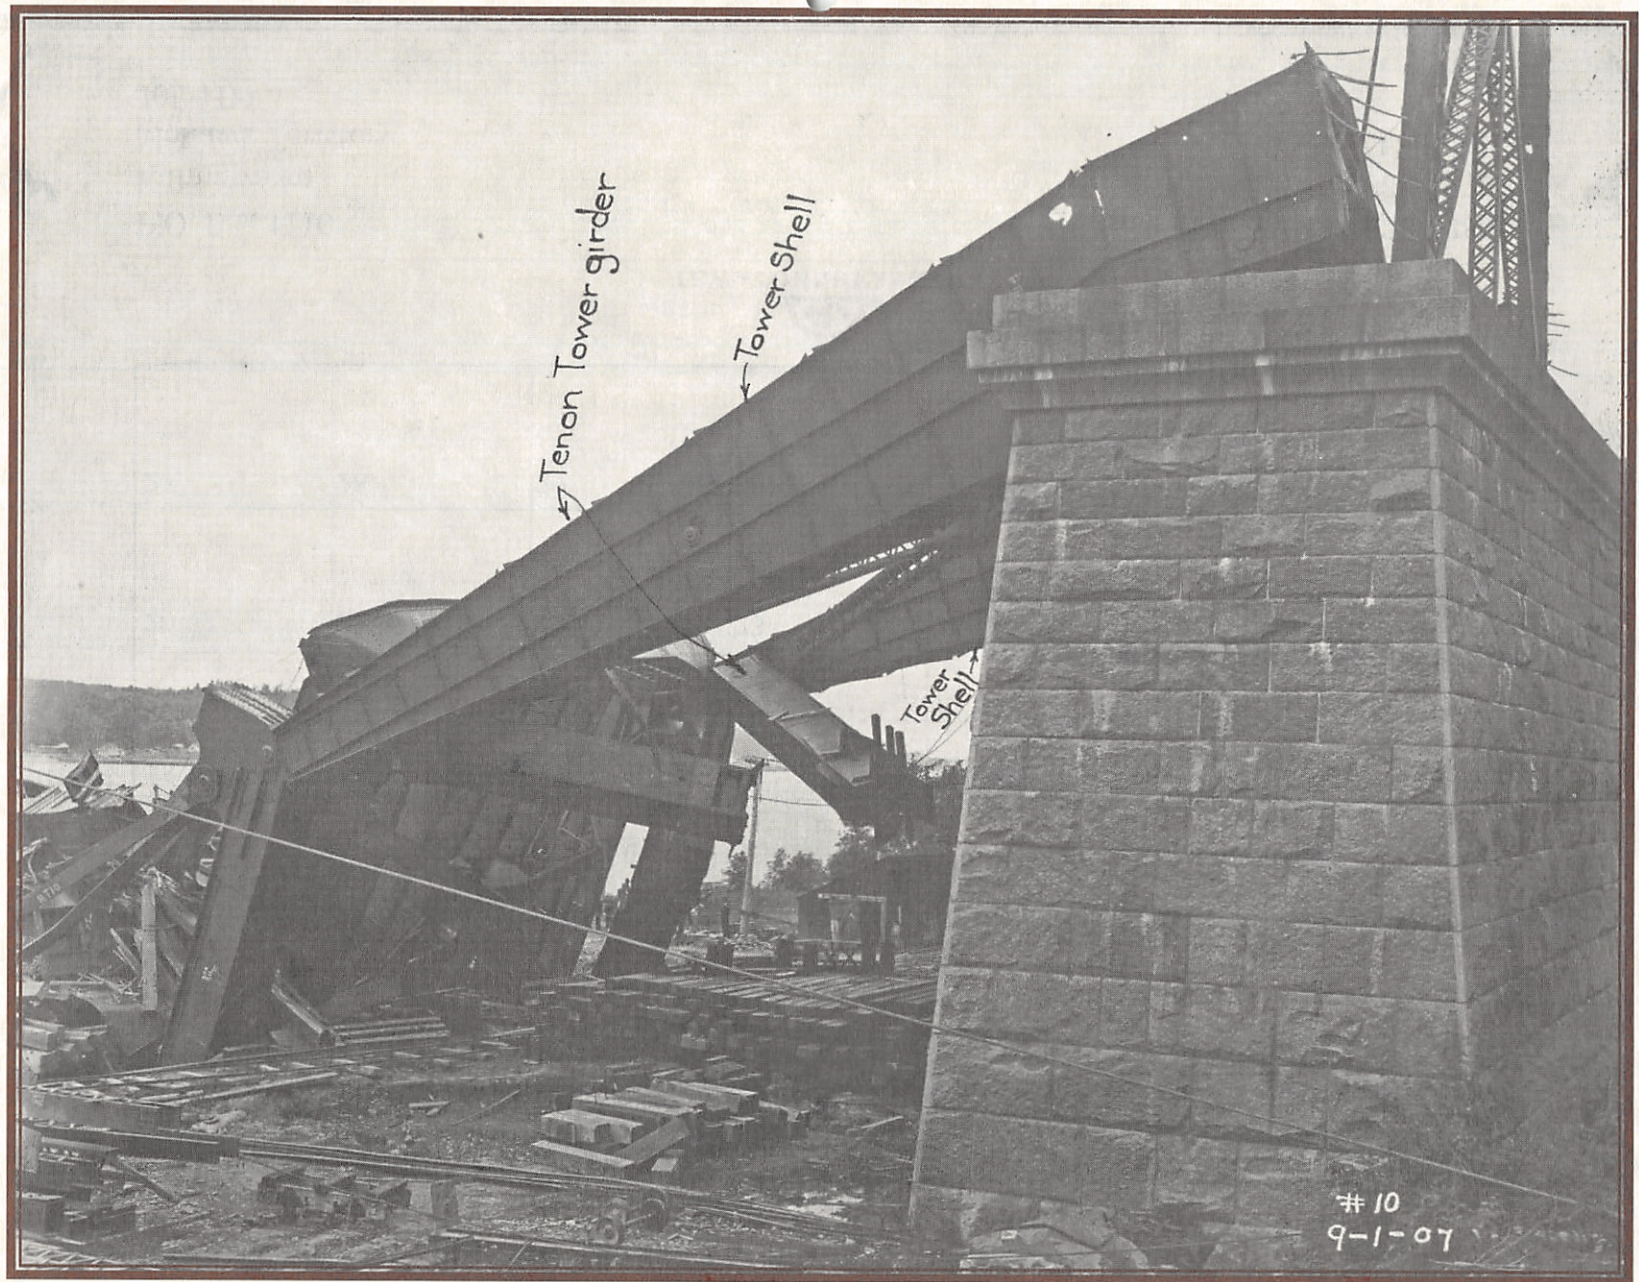
View from the west near the anchor pier. Note the towershells; the anchor bolts pulled out of the masonry; the broken tenon girder, which transmitted the horizontal wind reaction to its anchorage.

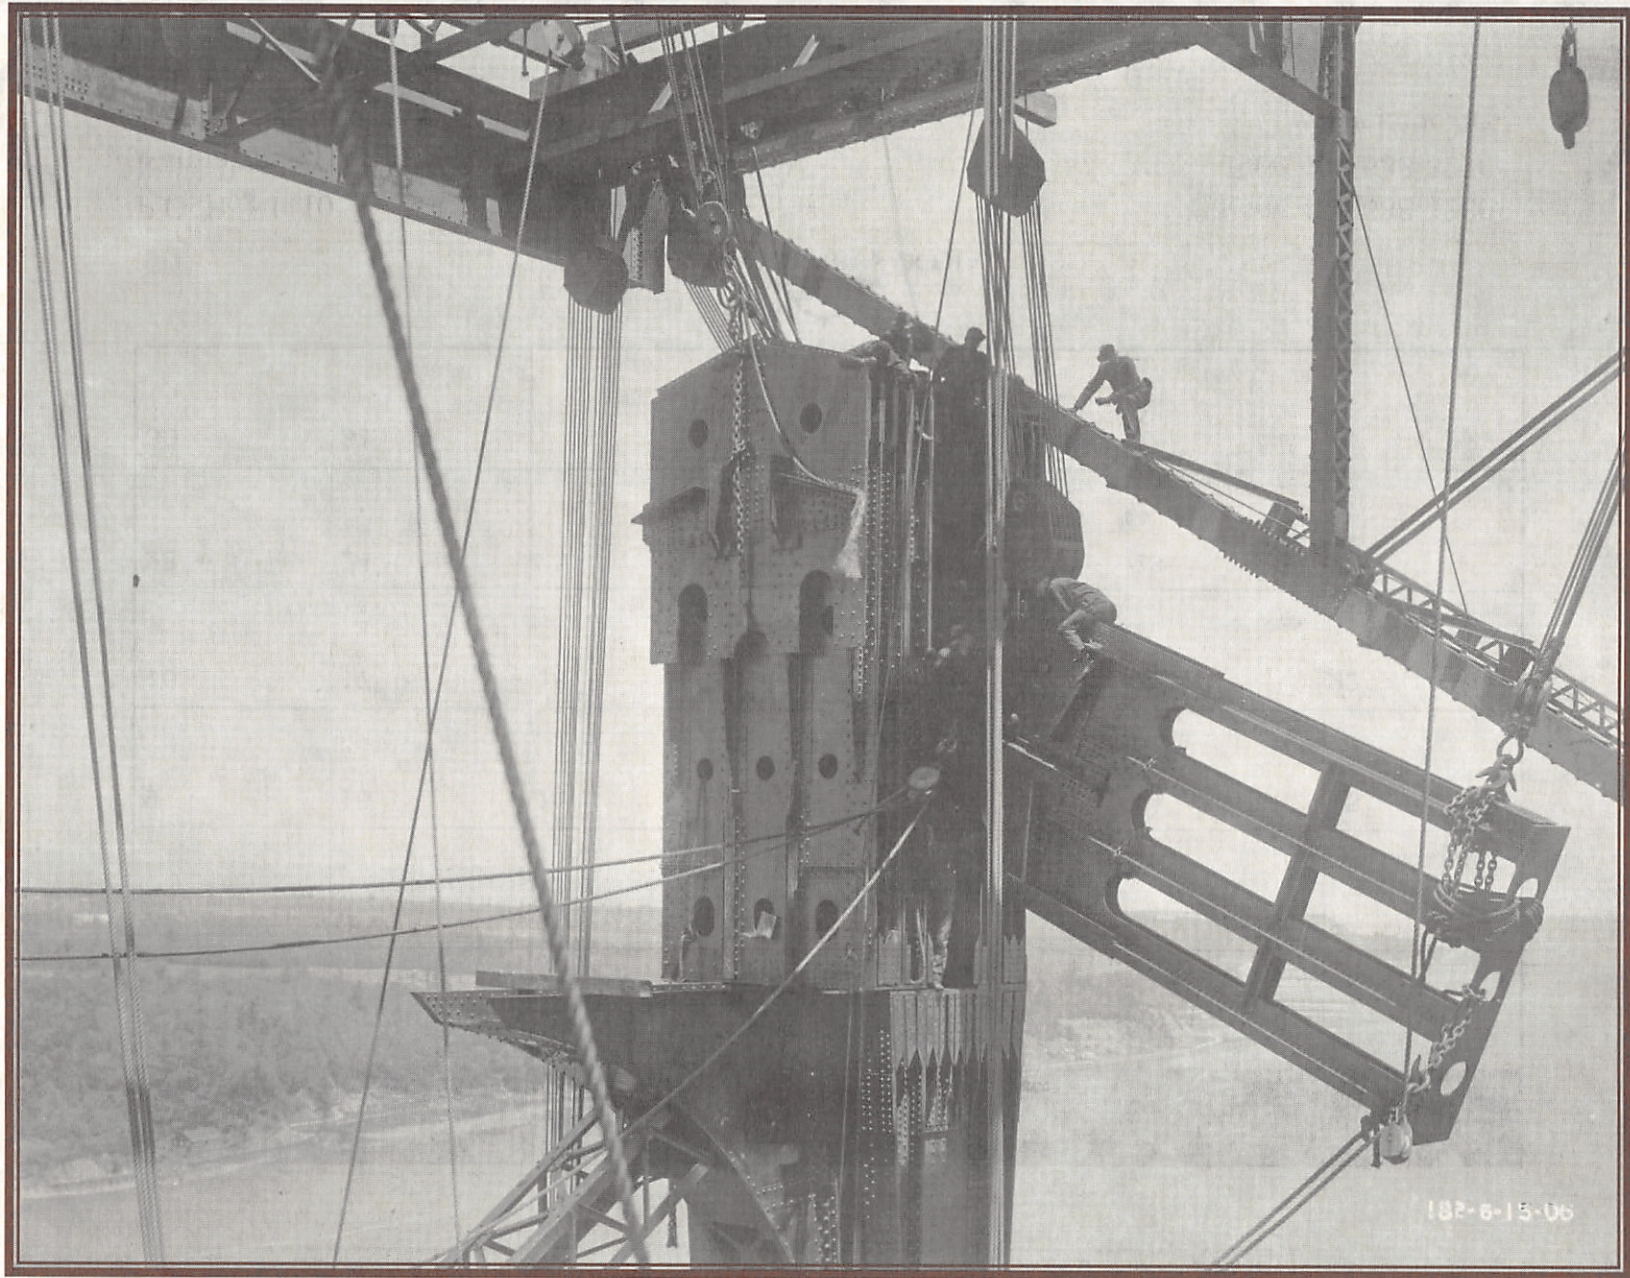
View showing the erection of a center post cap. Note that the cap could not be transported and erected as one piece and was built in three sections.
(June 15, 1906)

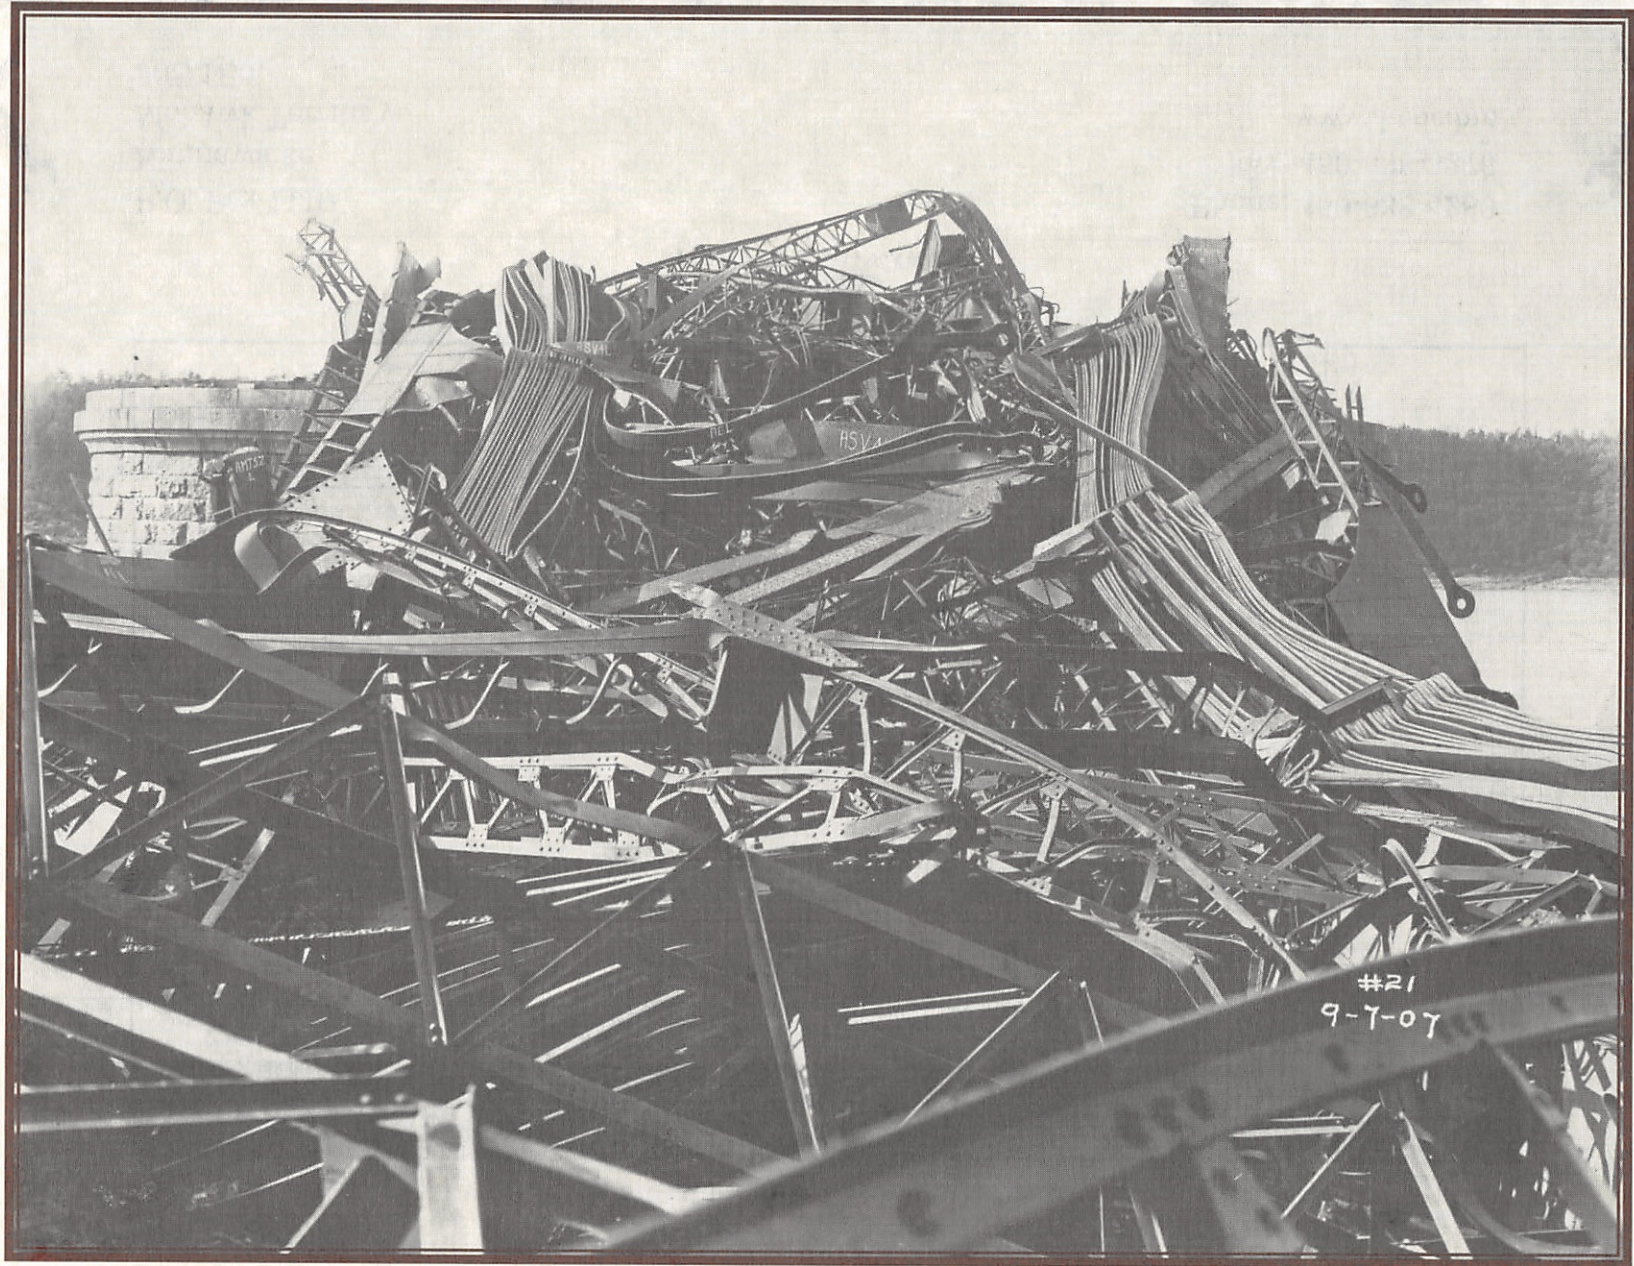
General view looking towards the main pier.
Note the upper chord on the right.

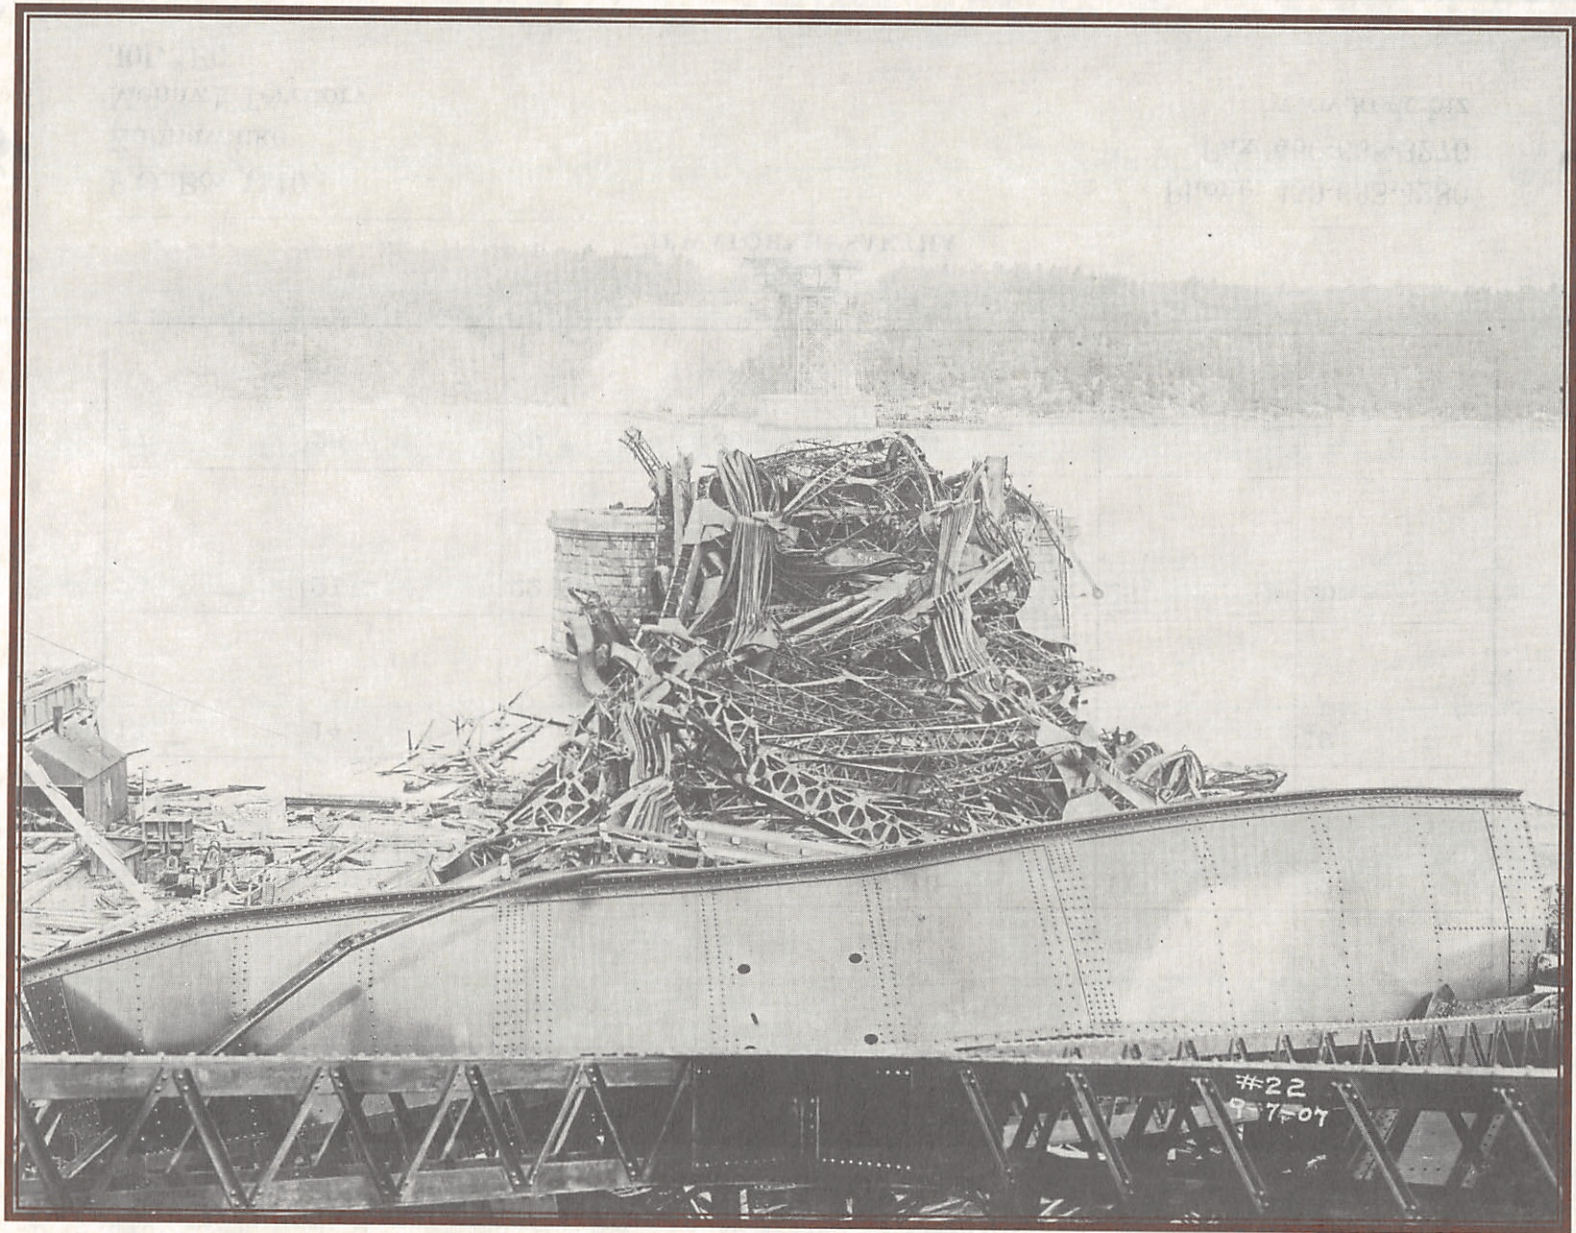
General view from the anchor pier northwards.
Note the position of the wreckage on the main pier.

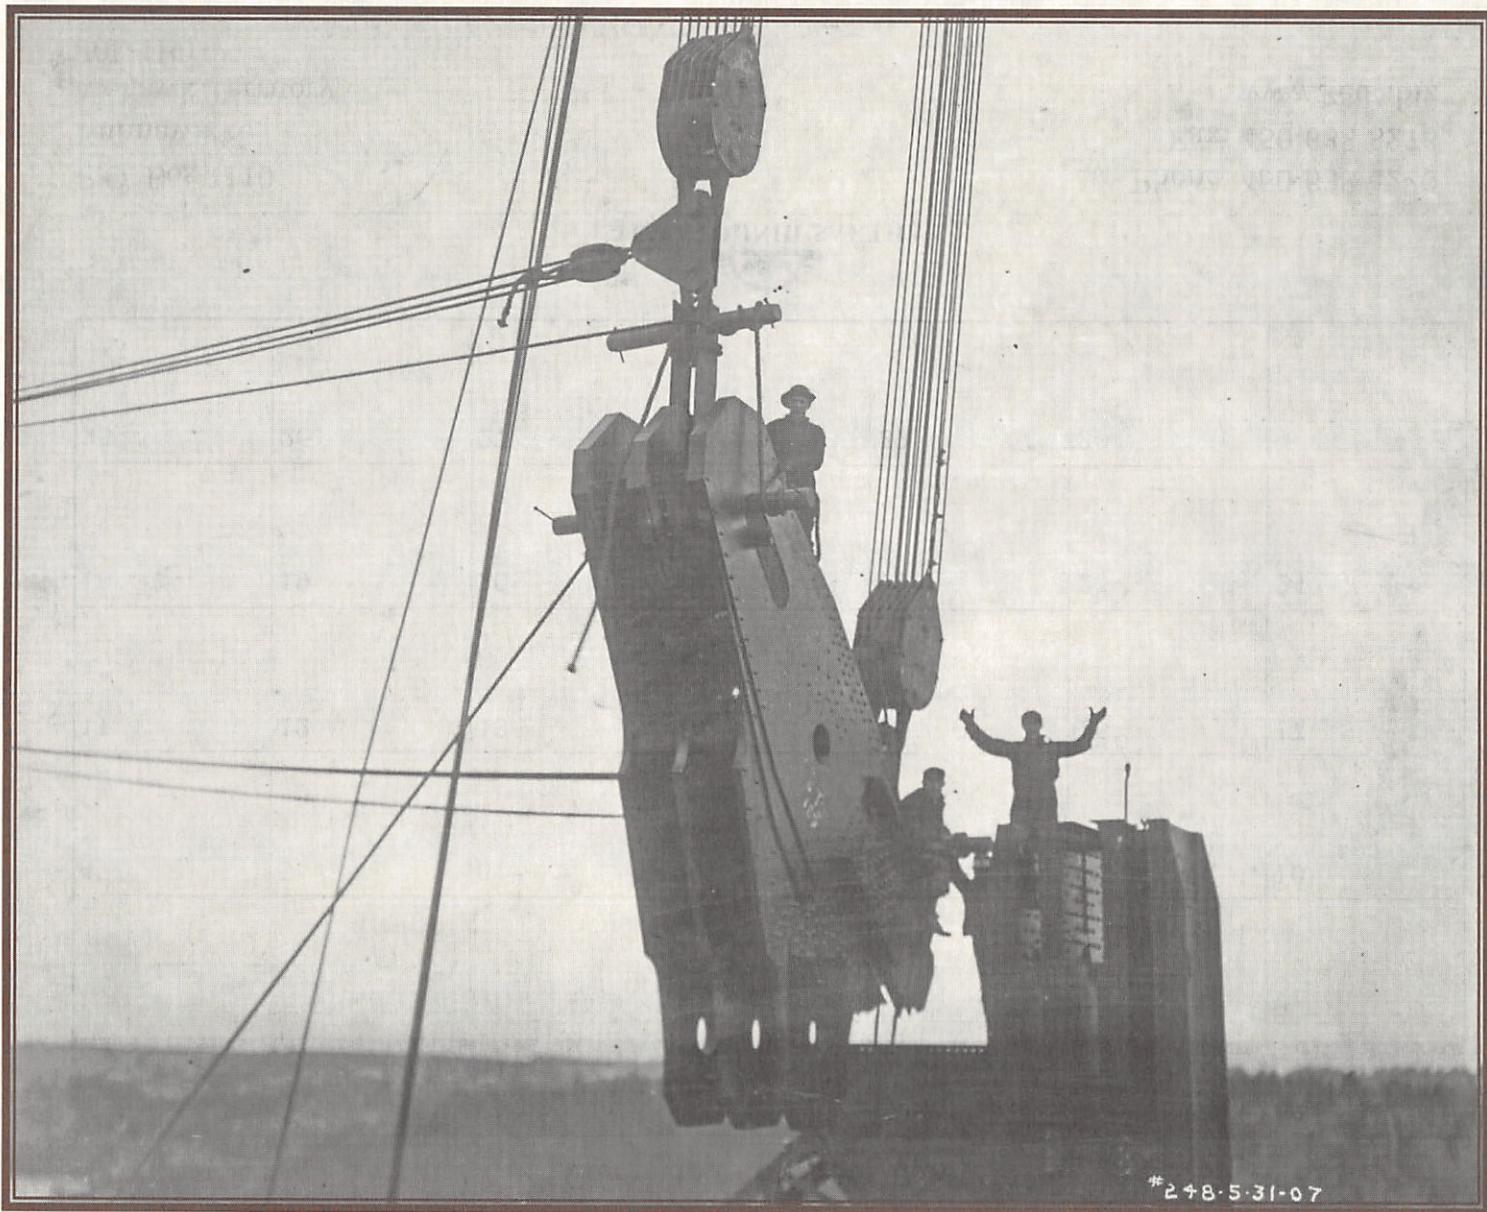
View showing the detail at the top of the end post of the cantilever arm.
(May 13, 1907)
