Quebec Bridge Disaster

August 29, 1907

A 17 Month Commemorative Calendar

On August 29, 1907, the unfinished Quebec bridge collapsed.
Seventy-five lives were lost,
thirty-three of whom were Kahnawa'kehró:non.
This publication is in honor of those men and their families.

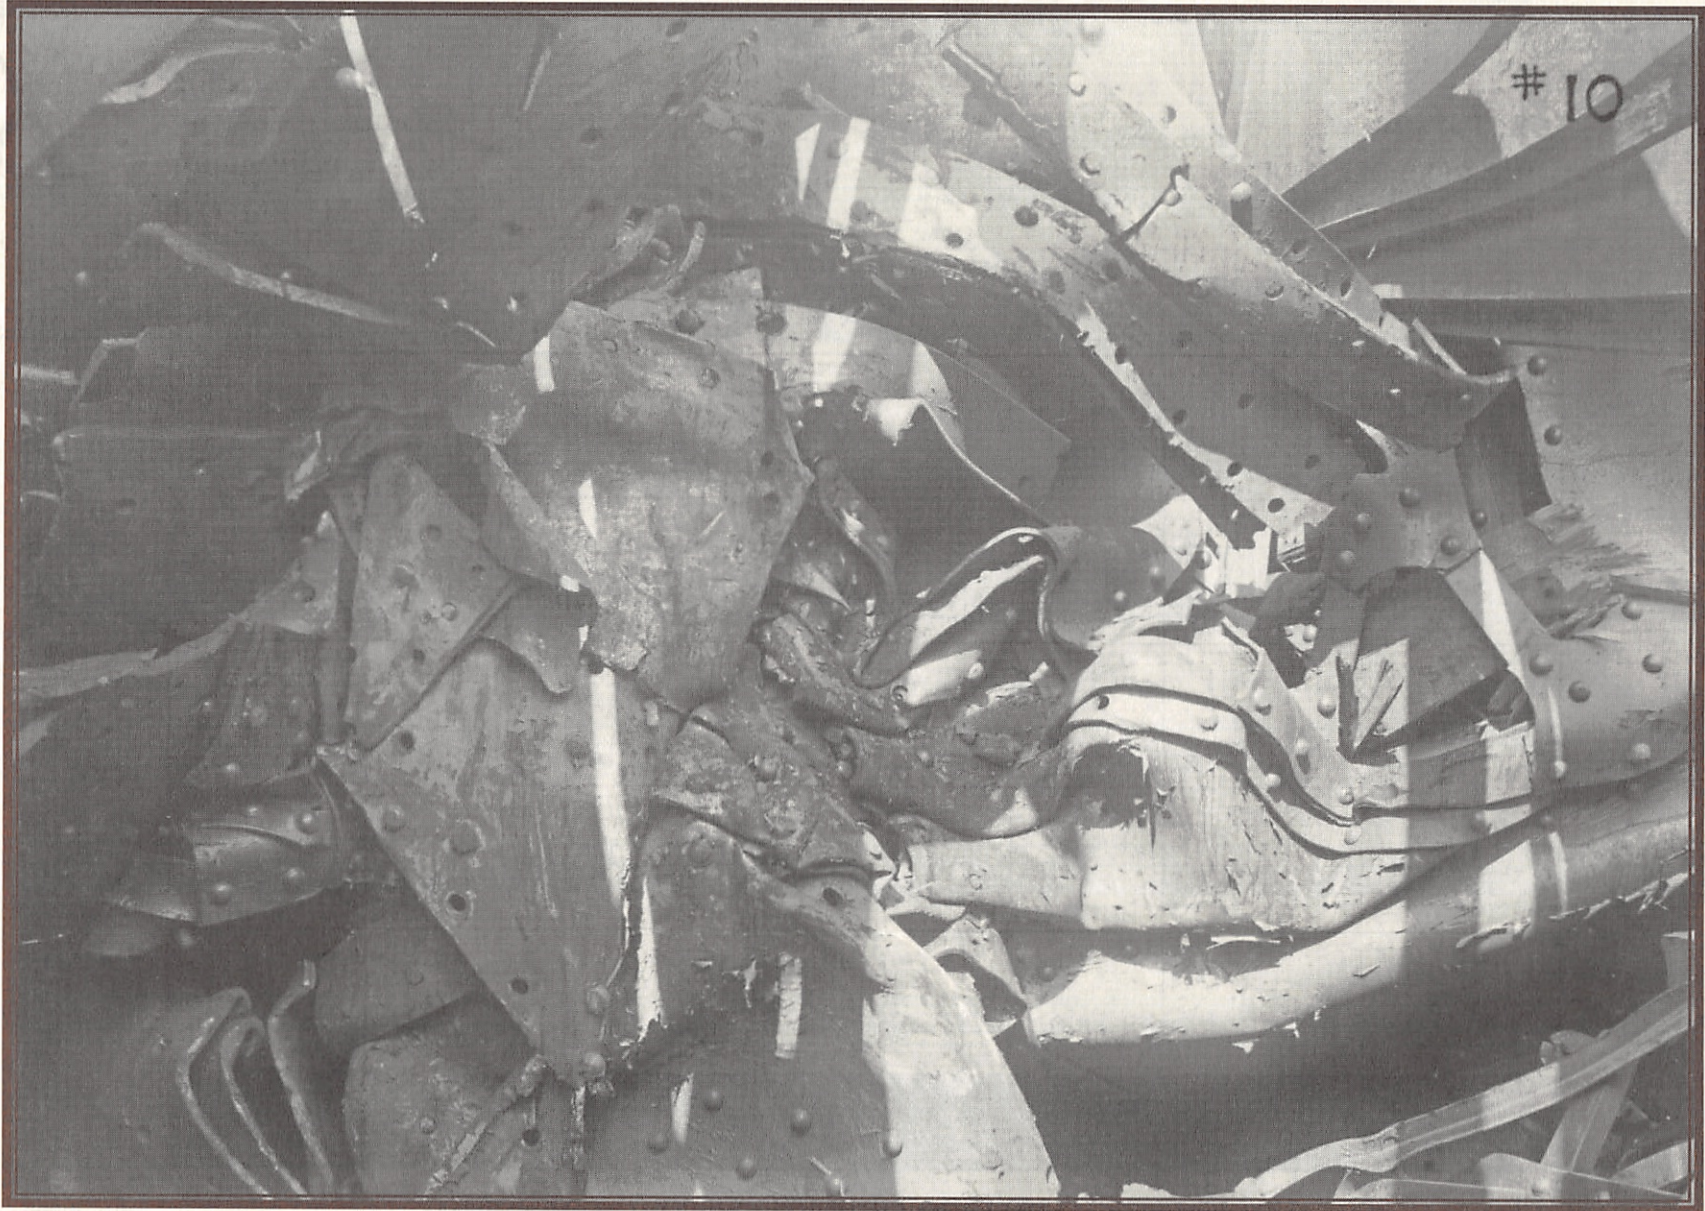
Shows complete chaos to be seen at some points of the wreckage.
This view is interesting only as an indication of the magnitude of the
forces at work during the catastrophe.
Even in this distorted mass there is no evidence of poor material.

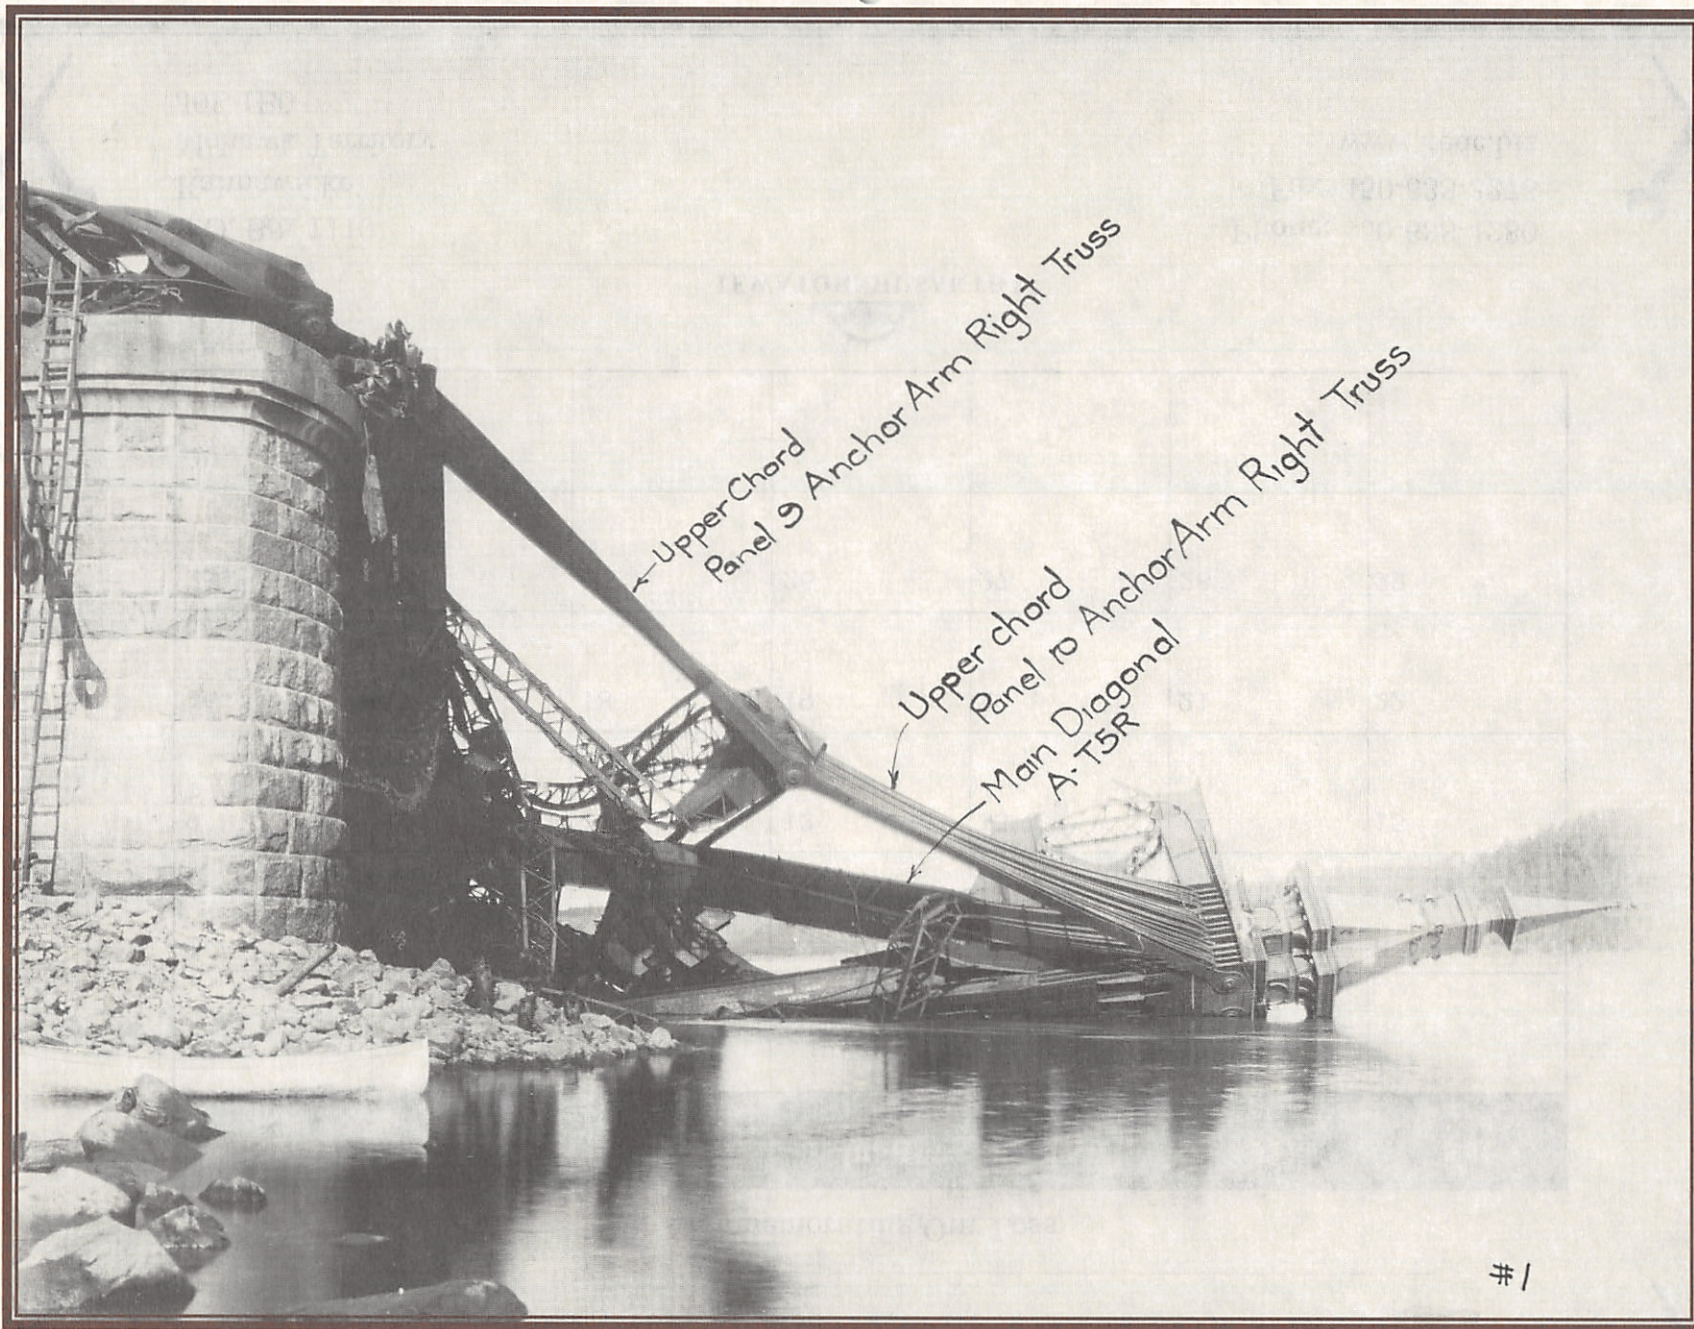
View showing center post, cap, finials, diagonal T.5 and the upper chords in panels 9 & 10, anchor arm. The center post has been practically bent double over the main pier by the drag of the cantilever arm. Note that the end of the pier is clear of wreckage.

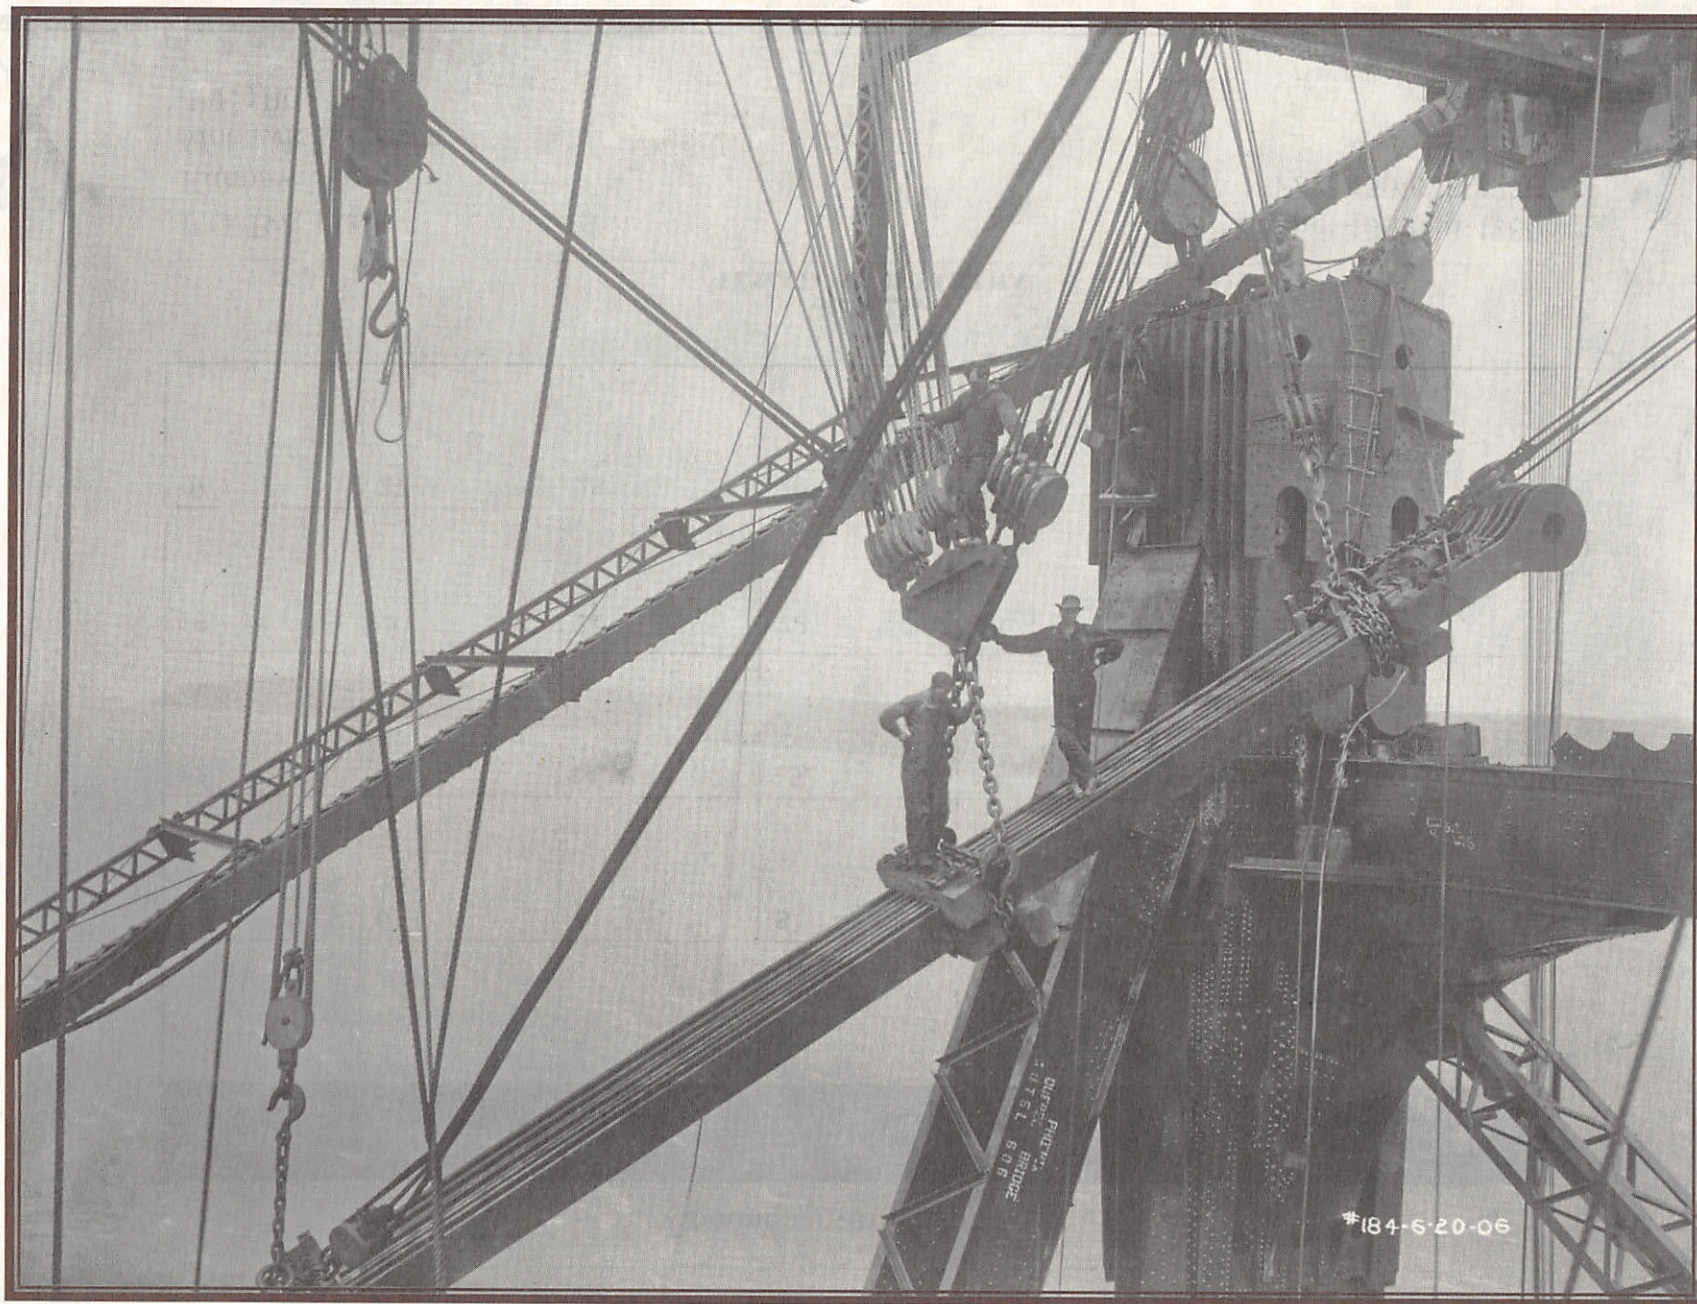
View showing the raising of a set of top chord eyebars.
Note the various tackles. (June 20, 1906)

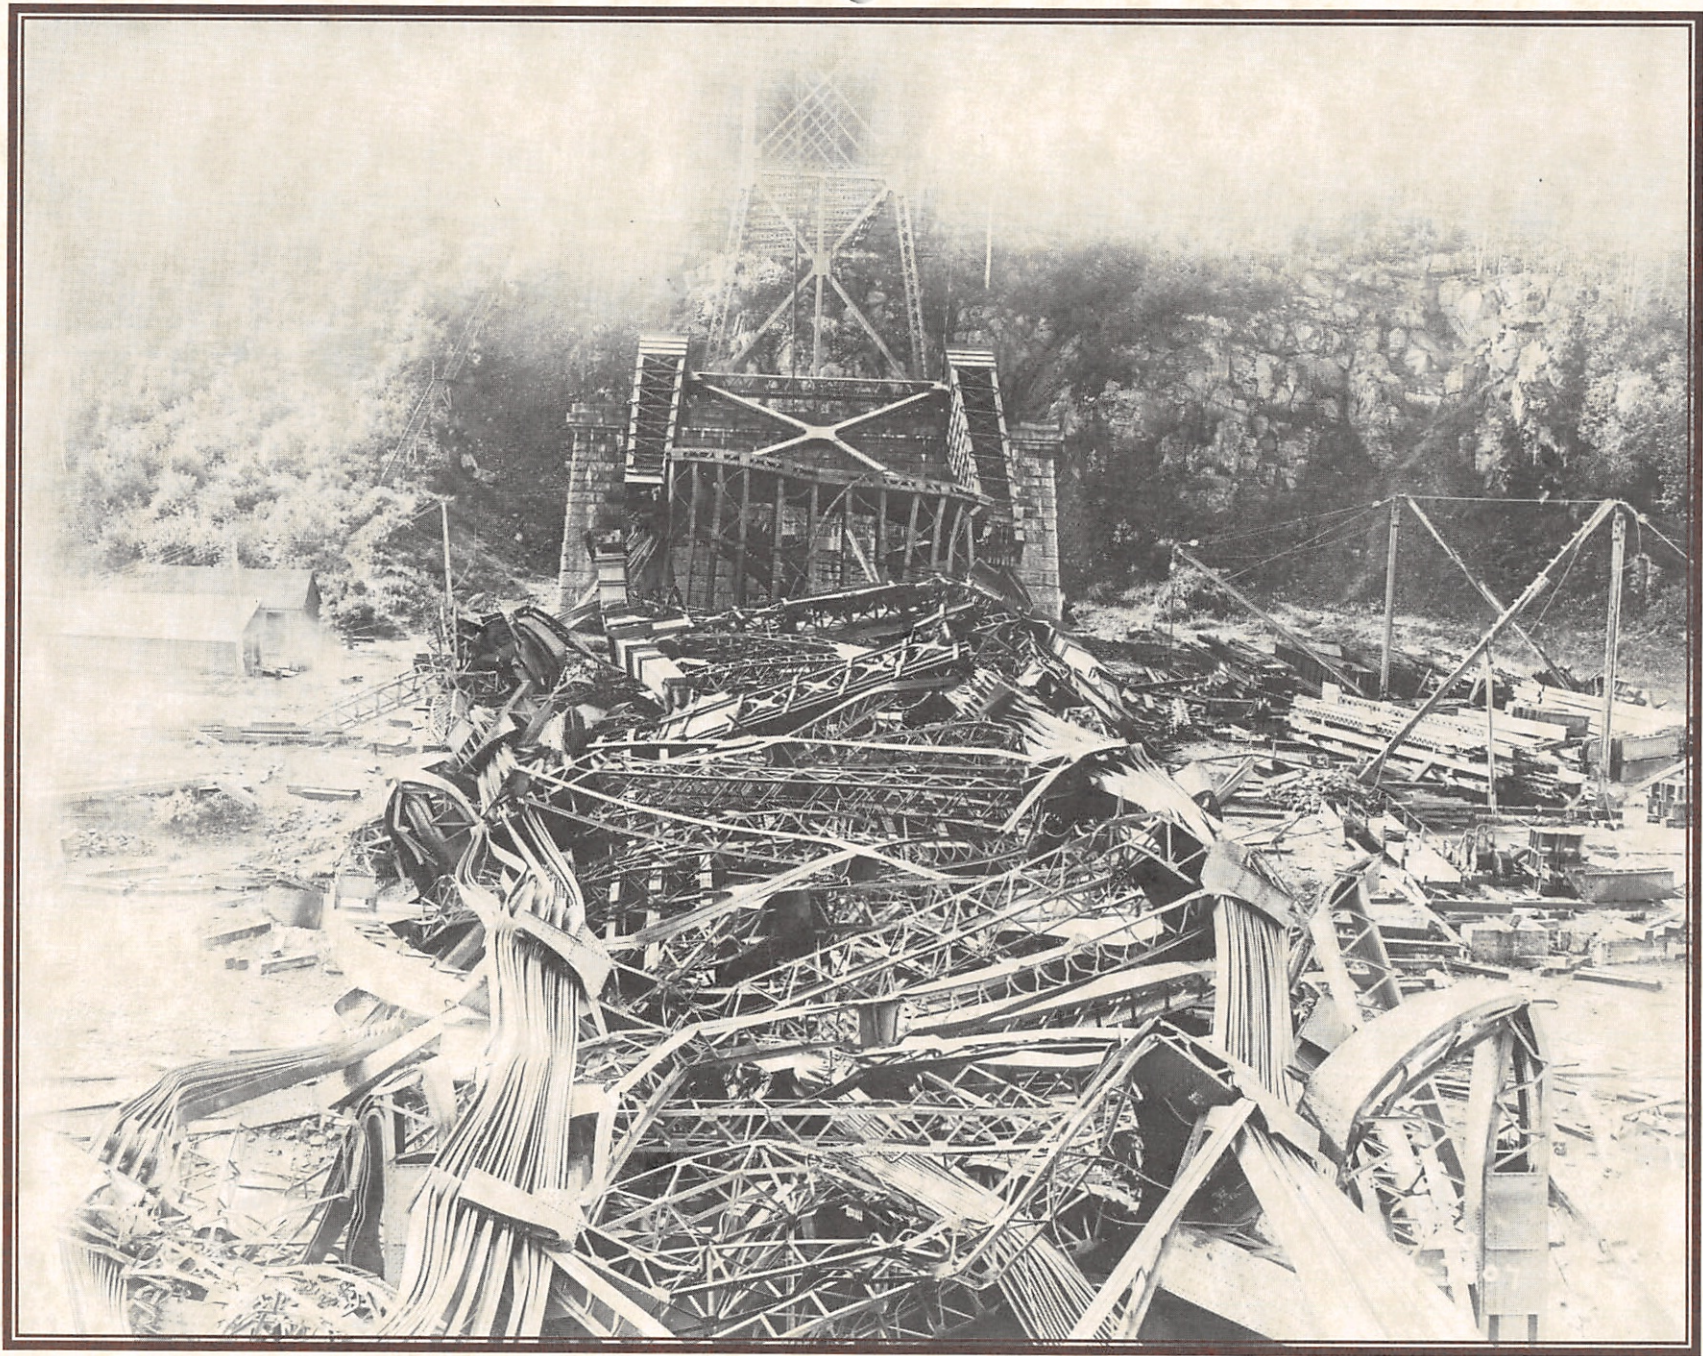
General view of the main pier southwards.
Note the moderate damage to the upper laterals.
